In the Club

BY JORIEN BAZA, P.E., AND PATRICK M. HASSETT, S.E.

One Las Vegas nightclub becomes another thanks to an intricate structural addition and reconfiguration project.

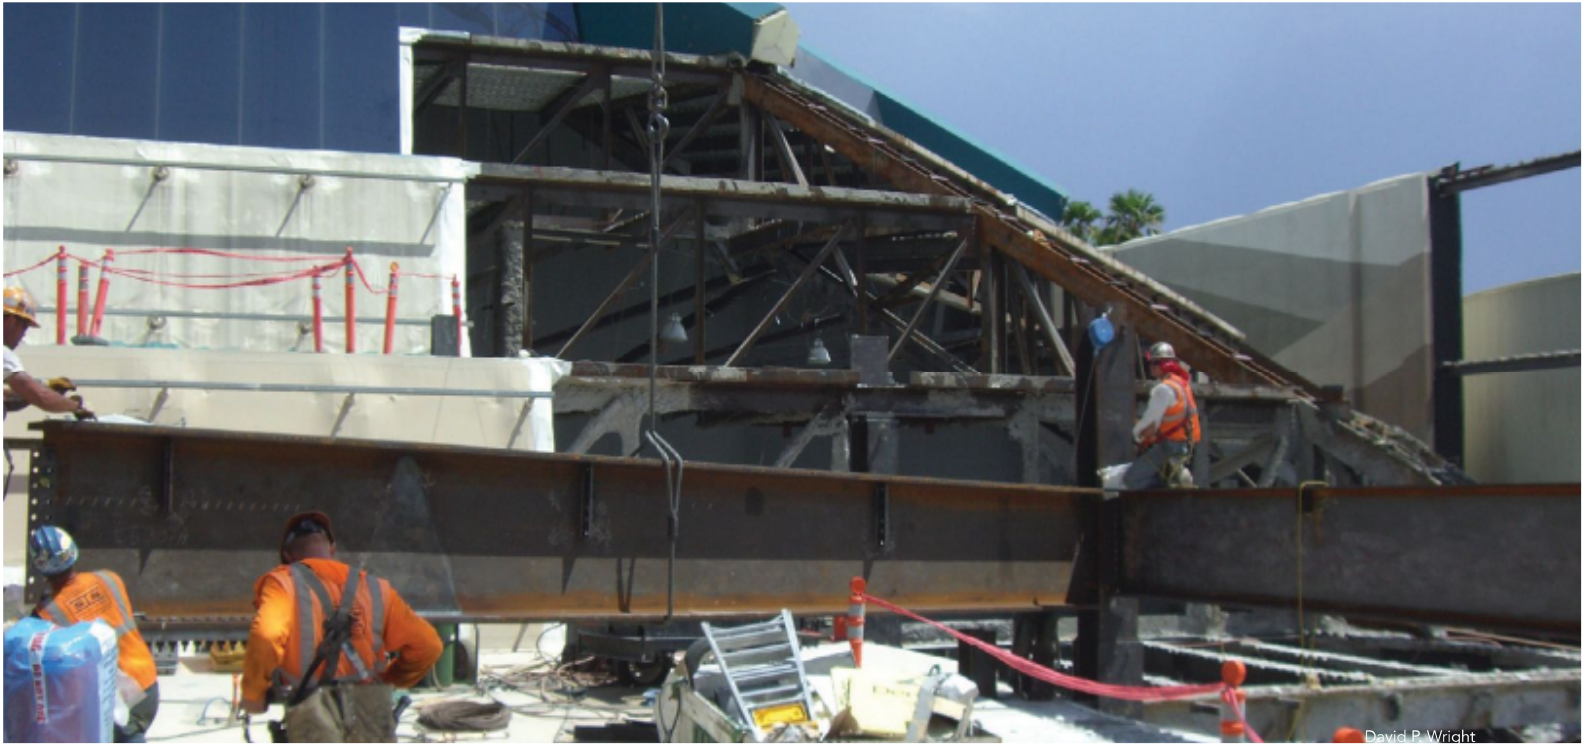
▼ Areas of work.

- ▲ New steel being incorporated into the existing frame.
- ◀ Hold-downs for the cantilever spreader beams.

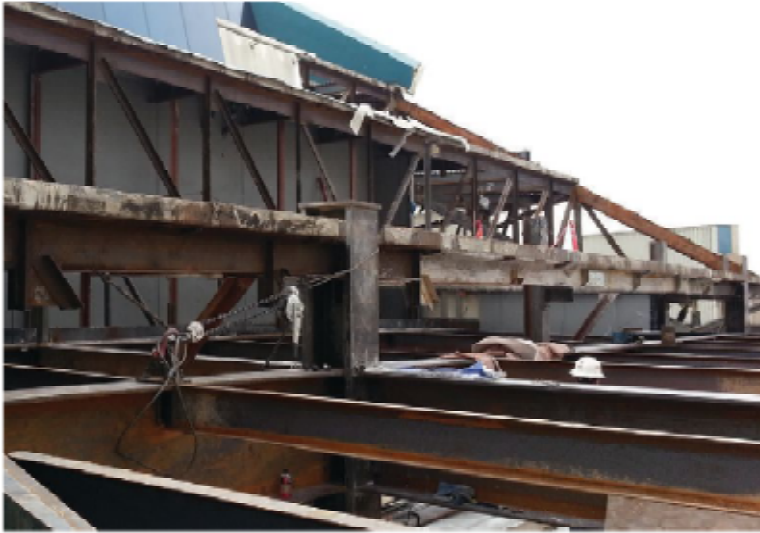
- ▲ An example truss top chord with two shoring posts.
- ▶ Example of truss chord shoring (side view).

Each truss had stages of demolition and retrofit that occurred concurrently with the erection of new beams and columns. Since many of the trusses called for the diagonal members to be removed, shoring columns were designed to support the top chords using short cantilever beam stubs with bolted end plates; the typical shoring column consisted of two W8x35

spreader beams supporting a W10x49 column with W8x24 cantilevers. The trusses consisted of WT12 chords with double-angle web members. The outrigger arrangement allowed new steel to be installed in the plane of the truss without conflicting with the temporary shoring column, and also allowed for one shore to support both top and bottom chords concurrently. The shoring locations depended on many factors: the length of the truss, the location of new and existing steel, the magnitude and location of the dead and live loads and the supporting structure below the truss.
